Saw Tooth Pattern in the UV Baseline - Troubleshooting

Date: 14-MARCH-2017 Last Updated: 11-FEBRUARY-2026

Why You May See a Saw-Tooth Pattern in Your UV Baseline

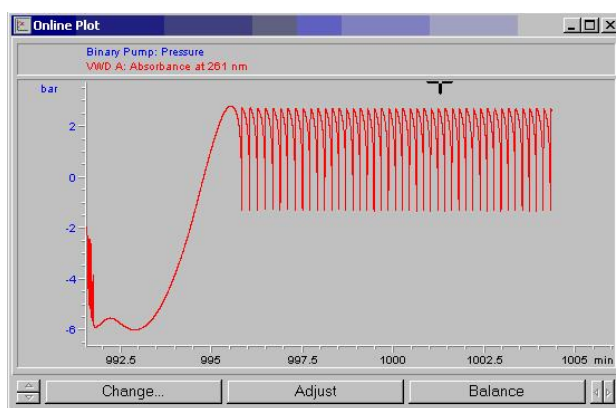
A saw-tooth or jagged repeating pattern in an HPLC UV baseline usually indicates the presence of residual immiscible solvents inside the column. Even trace amounts can disrupt flow uniformity and refractive index balance, causing the baseline to oscillate or “saw-tooth” as the mobile phase passes through.

This phenomenon can occur on any column, including Cogent TYPE-C™ columns, when incompatible or non-miscible solvents have been introduced at some point in the workflow.

- Small pockets of the immiscible fluid remain in the packing bed.
- These pockets intermittently disrupt the flow path.
- Localized disturbance causes fluctuating absorbance, resulting in the characteristic saw-tooth pattern.

Because TYPE-C columns have high surface area and hydride-modified silica, residual non-polar solvents can linger if not fully flushed. This especially occurs if the column was previously exposed to hexane or other non-aqueous, non-miscible solvents.

Flush the column overnight with a solvent that is mutually miscible with both the mobile phase and any residual trapped solvent.

✓ Isopropanol (IPA) IPA's intermediate polarity allows it to dissolve or displace both aqueous and organic residues inside the pore structure.

1. Stop the run and disconnect the column from the detector if needed.
2. Set the pump to run 100% isopropanol (IPA) or another suitable miscible solvent.
3. Begin at a low flow rate to avoid pressure shock.
4. Increase the flow gradually to the normal operating rate.
5. Flush overnight to ensure complete removal of trapped immiscible solvents.
6. After flushing, transition slowly back to your normal mobile phase.
